Preliminary Engineering Report

Water System Improvements

Scatchet Head Water District
PWS ID: 76470 X
Clinton, WA 98236

October 2020

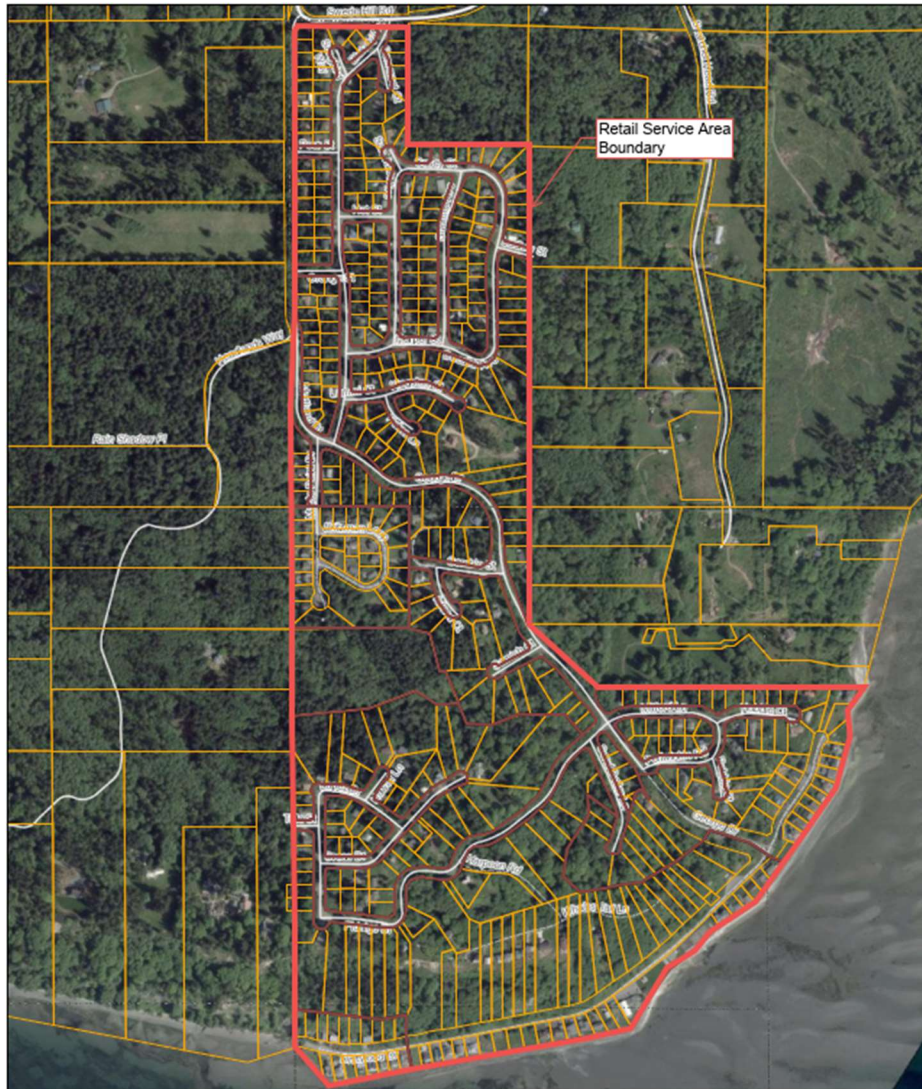
Figure 2: Scatchet Head Water District Service Area

The water system is located on the southern end of Whidbey Island between Cultus Bay and Useless Bay as seen in Figure 1. The service area for the system is shown in Figure 2.

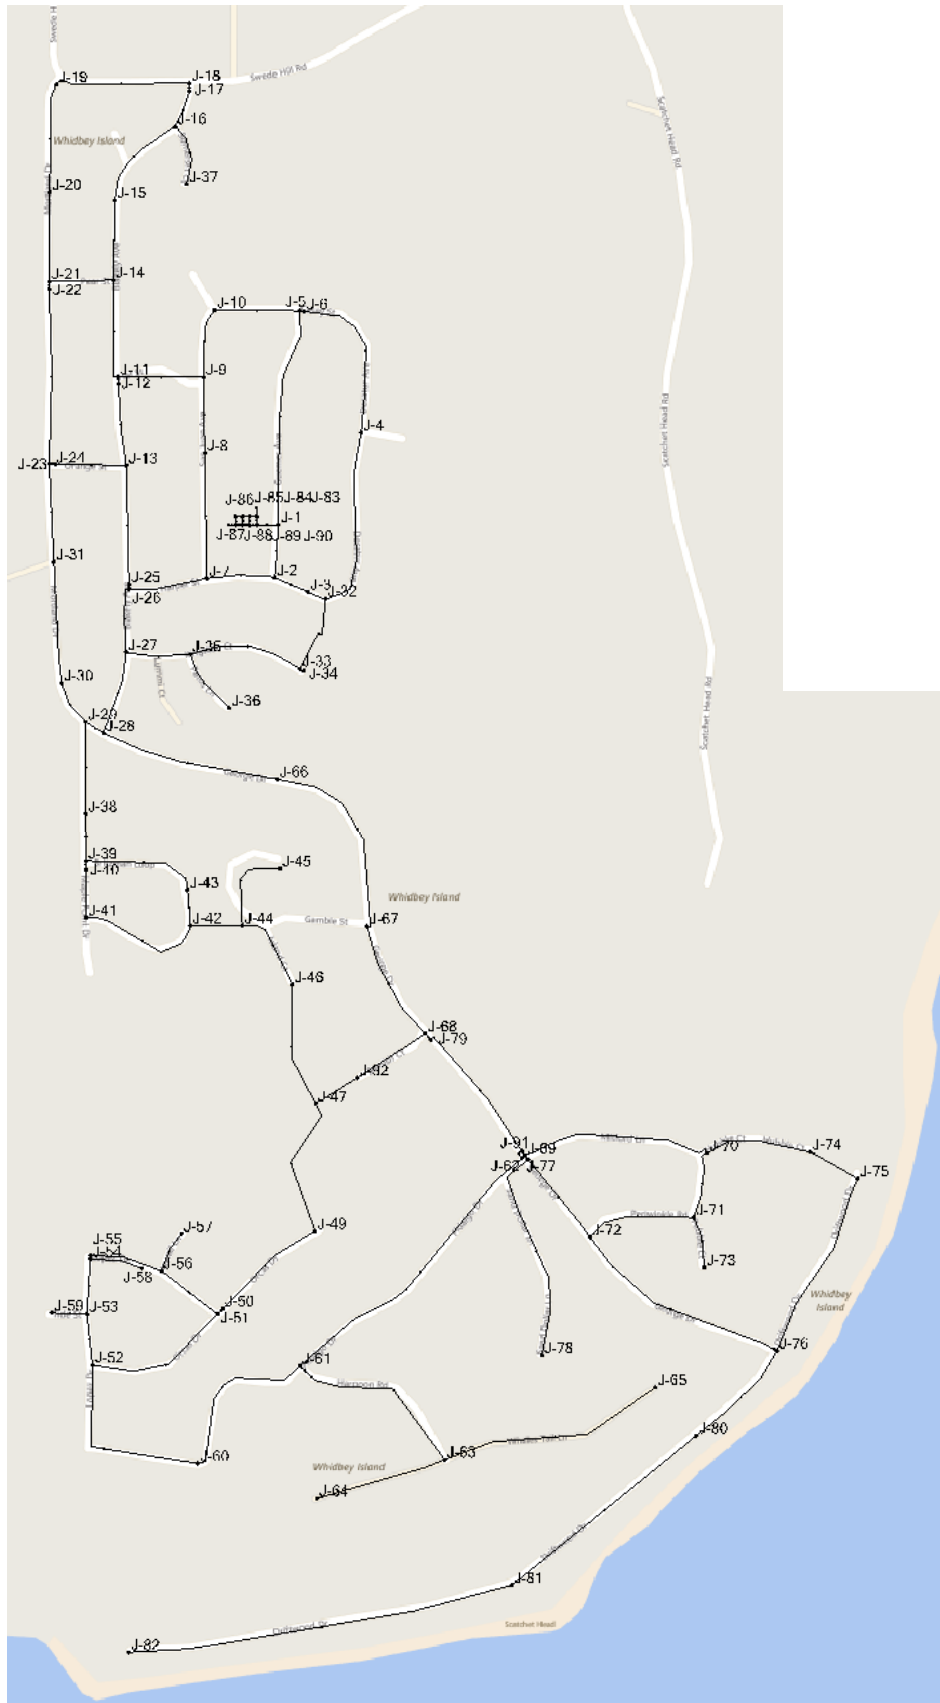
Hydraulic Model - Scatchet Head Water District

Bentley WaterCAD was used to create a hydraulic model of the preliminary design of the proposed distribution system. Three scenarios were modelled: Scenario 1 included no water demand and the high pressure setting, Scenario 2 modelled the system at PHD and the low pressure setting, and Scenario 3 modelled fire-flow at MDD. Model results are summarized below. Detailed results can be found in Appendix G.

Scenario 3 represents the system during fire-flow situation during MDD. The MDD that was used is 425 gpd/ERU, as found in the 2020 Water System Plan. In 20 years, the system is anticipated to have 455 connections, therefore the overall MDD of the system that was modelled was 193,375 gpd or 135-gpm. A demand of 500-gpm was also placed on the fire-hydrant at the highest elevation within the system
